# Manhole Inspection Summary

## Manhole # S31EE1012MH

Insp Date: **3/19/07 4:06 PM**

**Location** Address: **3811 CANTERBURY RD** Cross Street: **UNIVERSITY PKWY**

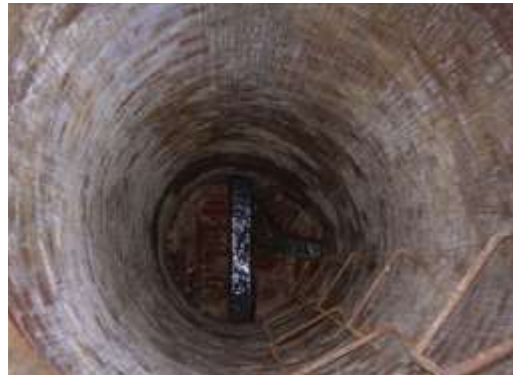
Top View

Corroded steps.

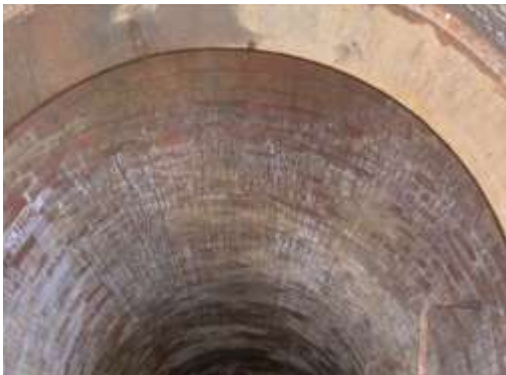
Defect

**Frame** Offset: **0** (in.) Condition: ☐ Sound ☐ Cracked ☒ **Leaks**

**Corbel** Material: **Brick** ☐ Parged Type: **Concentric/Eccentric**  
Condition: ☒ Sound ☐ Cracked ☐ Root Intrusion ☐ Loose Brick ☐ Deteriorated  
Infiltration: ☐ None ☒ **Joint** ☐ Cracks ☐ Mortar ☐ Roots ☒ **Wall**

**Barrel** Material: **Brick** ☐ Parged  
Shape: **Circular** Diameter: **48** (in.) Length: (in.)  
Condition: ☒ Sound ☐ Cracked ☐ Root Intrusion ☐ Loose Brick ☐ Deteriorated  
Infiltration: ☐ None ☐ Joint ☐ Cracks ☐ Mortar ☐ Roots ☒ **Wall**

Frame leaks. Corbel and Barrel infiltration.

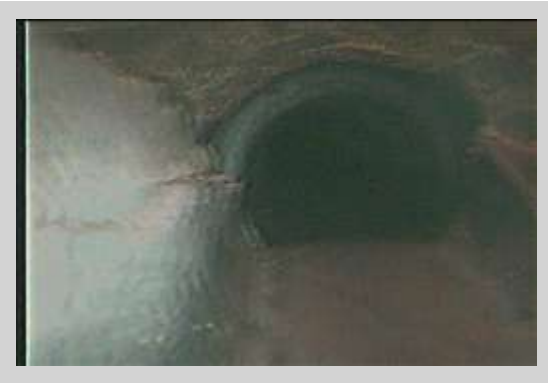
### 8 in. Circular Gravity Sewer Pipe Out @ 12 O'Clock

Pipe Material: **Clay** ☐ Pipe Lined

Invert Depth: **16.31** (ft.) Flow Characteristics: **Fast**

Infiltration: **None** Pipe Seal Cond: **Unknown**

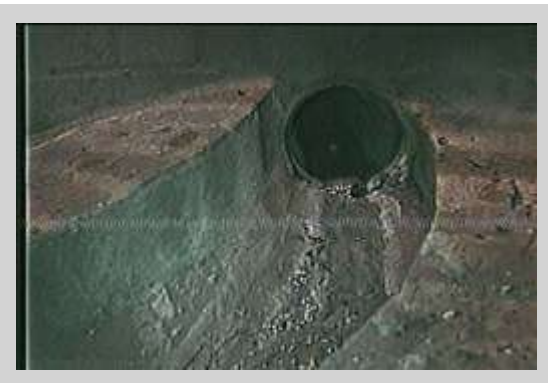
### 6 in. Circular Gravity Sewer Pipe In @ 3 O'Clock

Pipe Material: **Clay** ☐ Pipe Lined

Invert Depth: **15.62** (ft.) Flow Characteristics: **None**

Infiltration: **None** Pipe Seal Cond: **Unknown**

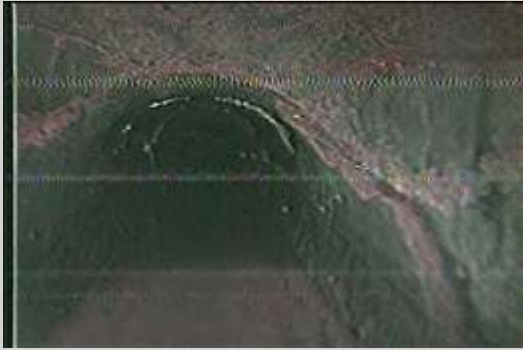
8 in. Circular Gravity Sewer

Pipe Material: **Clay**

Invert Depth: **16.30** (ft.) Flow Characteristics: **Fast**

Infiltration: **None**
